NIST NCSTAR 1-5A

**Federal Building and Fire Safety Investigation of
the World Trade Center Disaster**

Visual Evidence, Damage Estimates, And Timeline Analysis

William M. Pitts
Kathryn M. Butler
Valentine Junker

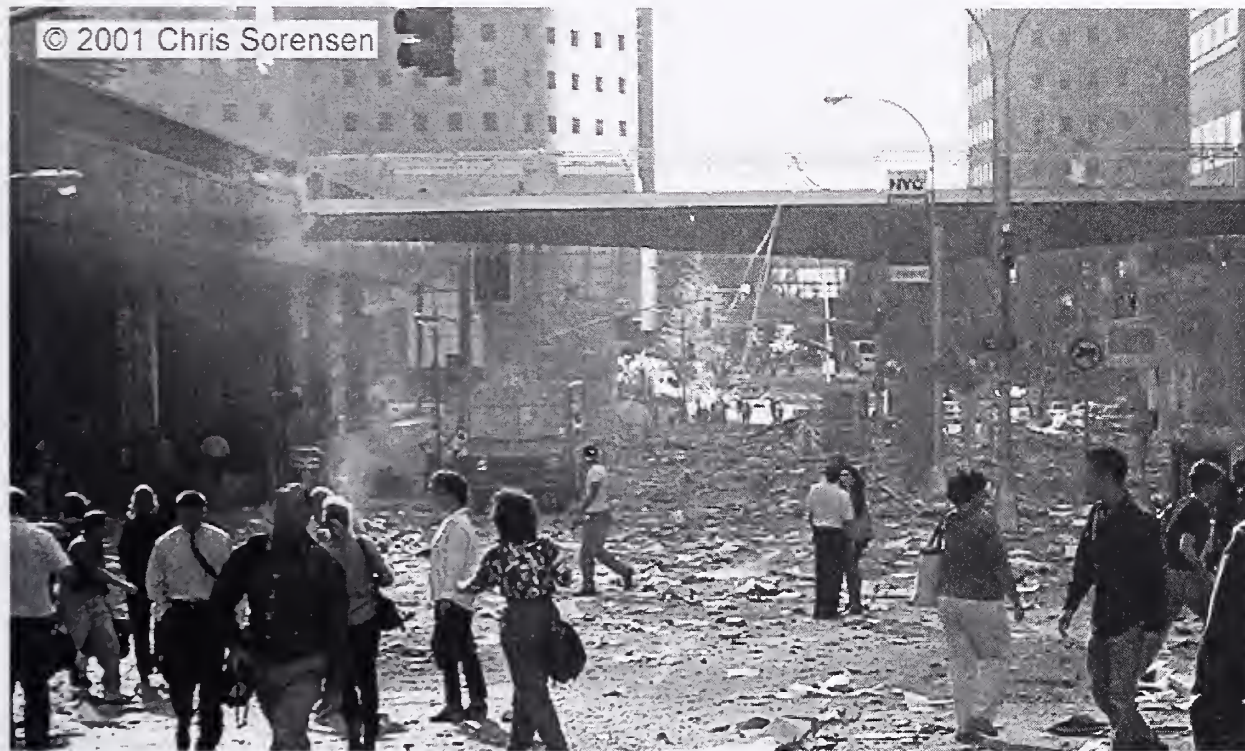
Figure 6-15 shows another view of the streets around the WTC shortly after the aircraft struck WTC 1. This shot was taken from the corner of Liberty Street and Church Street looking west down Liberty Street. It was taken before WTC 2 was struck, so the debris has come from WTC 1. The bridge across Liberty Street connected the southwest corner of WTC 4 to the Bankers Trust Building. The building visible on the right side beyond WTC 4 is WTC 3 (Marriott Hotel), which was located on the corner of West Street. A deep layer of debris is seen strewn across much of the visible length of Liberty Street. Most of this debris is lying to the south of WTC 2. The only possible way for it to have reached this location is by being blown by the prevailing wind from the south face of WTC 1. It is likely that it was dropped from the dust cloud seen to the south of WTC 2 in Figure 6-2. This image, along with several others, shows that, in addition to a lot of paper, the debris in the street consisted of a number of aluminum column covers and what appeared to be small chunks of concrete. The amount and nature of the debris

indicates that the aircraft impact and fireballs must have caused significant damage close to and on the south face of WTC 1. There were also a number of small fires burning on Liberty Street immediately following the aircraft impact (not visible in Figure 6-15).

Figure 6-15. This photograph was taken from the corner of Liberty Street and Church Street looking west down Liberty Street after WTC 1 was struck by American Airlines Flight 11 but before WTC 2 was hit by United Airlines Flight 175. Some faces are blurred.

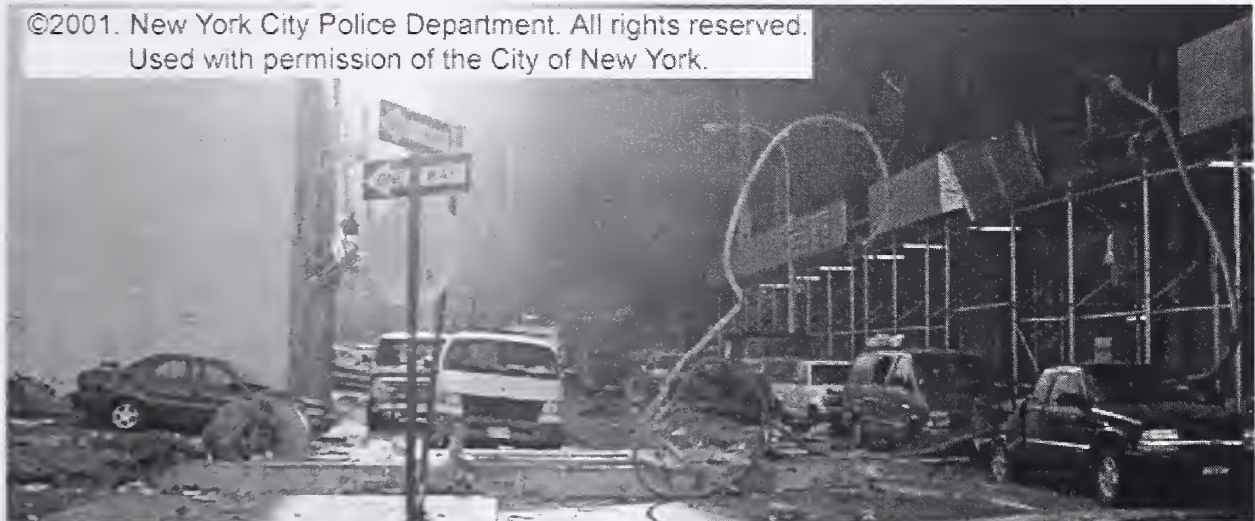
A curious aspect of Figure 6-16 is the large pipe that can be seen twisted about and rising above the panel section. A different view of the pipe is available in Figure 6-17, where it can be seen that it extends from well above the panel section across the pickup truck to the right and then up into the air. The force of the collision of the pipe with the pickup has crushed the cargo bay. The pipe section length is considerably longer than the panel section, which is 36 ft. The pipe diameter has been estimated as 1.5 in., based on its size relative to the panel section.

Figure 6-17. This cropped and enhanced photograph shows another view of the three-story steel panel section included in Figure 6-16. A long pipe section attached to the steel rises above both the panel section and the pickup truck to the right. The building on the left is Saint Nicholas Greek Orthodox Church, and the building on the right is 90 West Street.

Review of building plans and consultation with The Port Authority of New York and New Jersey staff and consultants have provided a plausible explanation for the source of this pipe. Cooling at the perimeter of the towers was accomplished by means of cold-water induction units located along the outer wall at the base of the windows. These units were fed cooled water by a series of vertical risers (pipes) that extended either up or down from the mechanical equipment rooms. Water was returned by parallel risers. The pipe in the figures seems to be attached to the bottom of the steel panel section on the center column, i.e., column 130 at the 93rd floor. Induction units on the 92nd floor and higher were connected to the mechanical equipment room on the 106th floor. Building plans indicate that supply and return risers were located just to the inside of column 130. The supply riser was 1.5 in. pipe and the return riser was 2 in. pipe. The appearance and location of the pipe in the figures indicate that it is mostly likely part of a supply riser that fed the induction coolers at this location.

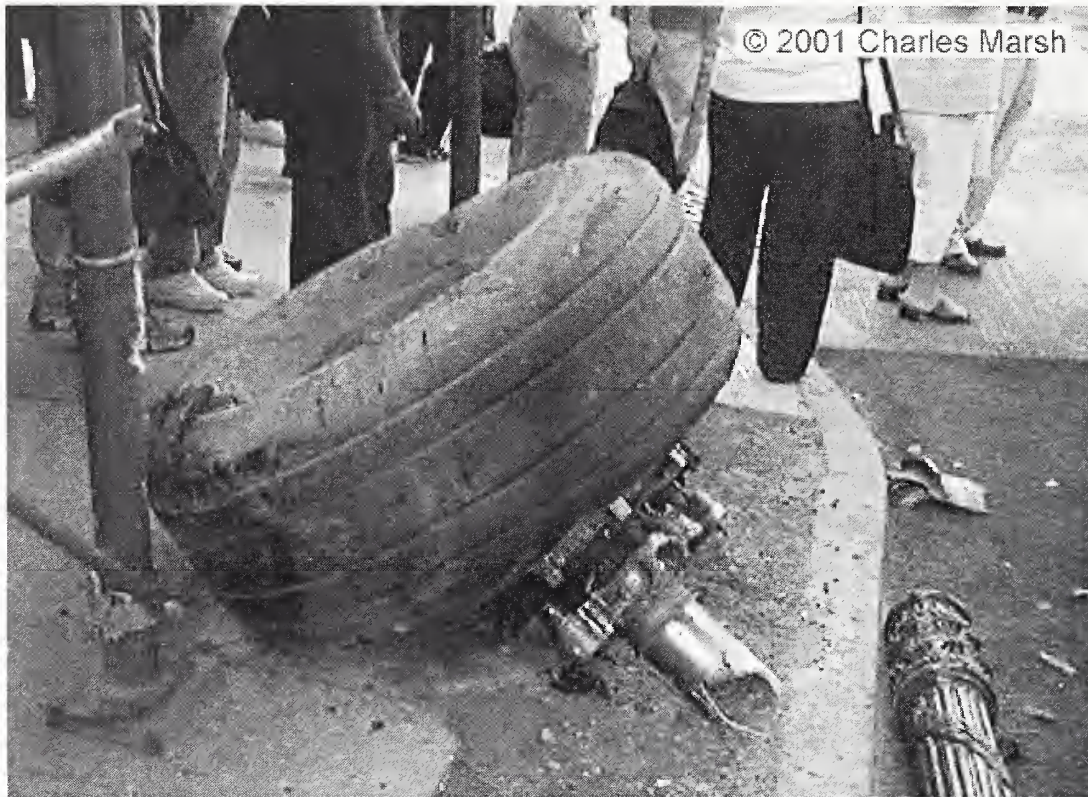
A second wheel from a landing gear, shown in Figure 6-18, was found much further south at the corner of Rector Street and West Street. This is a distance of roughly 1,385 ft from the base of the south face of WTC 1. The presence of a braking system indicates that this wheel also came from one of the two main landing gears.

Figure 6-18. The photograph shows a wheel from the aircraft that struck WTC 1 lying at the southeast corner of the intersection of Rector and West Streets.

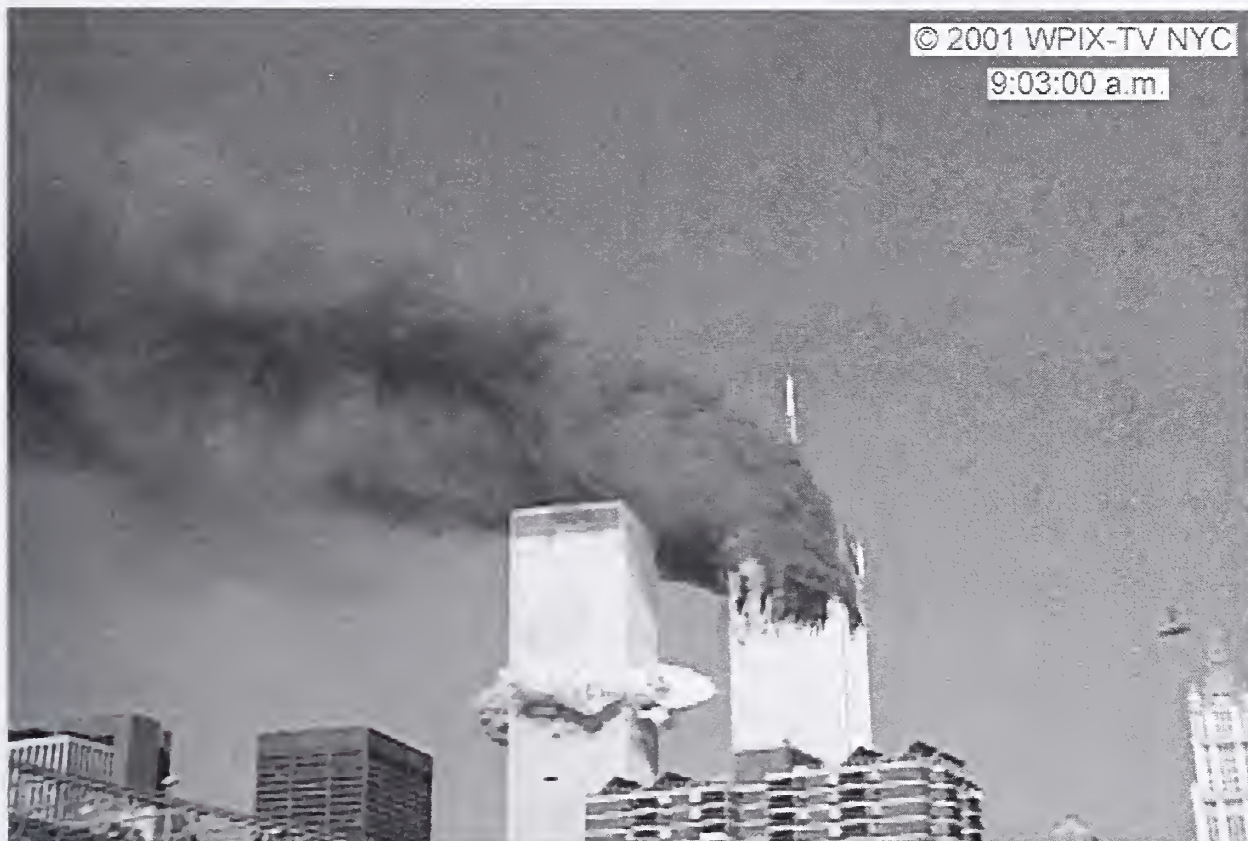
Close inspection of Figure 7-1 shows that there are three distinct fireballs present on the north face. Videos shot from the north indicate that the largest of these grew from the area of fire that originally

appeared on the 80th, 81st, and 82nd floors in the vicinity of windows 239 to 249 (see Table 7-1). The second, somewhat smaller, of the fireballs is at roughly the same height and emanates from near the northeast corner. The third fireball is the smallest and is located below the other two. Northern views show that this fireball was formed from fire exiting from windows 79-233 to 79-240 on the 79th floor (see Table 7-1).

Figure 7-1. The nascent fireballs and dust clouds formed on WTC 2 1.2 s after the aircraft impact on the tower are shown. The image is a frame from a video.

A large cloud of dust is evident in Figure 7-1 on the south face that does not appear to be burning despite the fact that ignition was observed on this face (see Table 7-1). It appears as if there was much less fuel in the material that was expelled from this face than observed on the east and north faces. Other regions of dust can be seen below the fireball on the east face and in the vicinity of the mechanical equipment room on the 75th and 76th floors on the east and north faces.

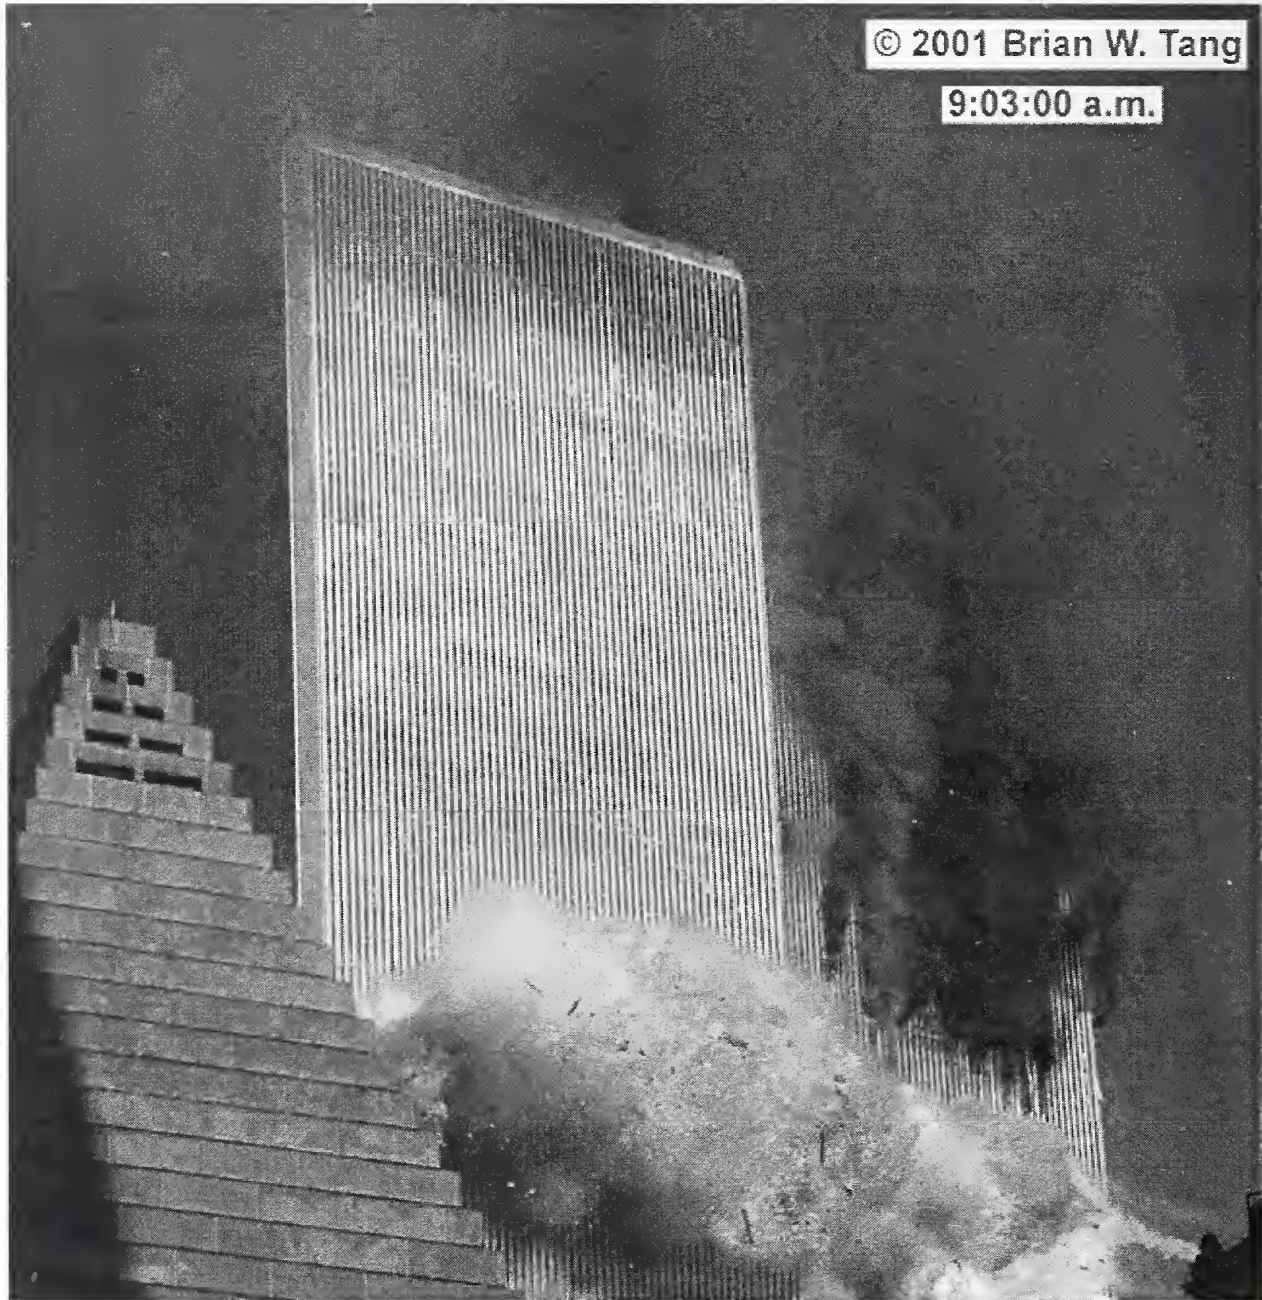
Figure 7-2. This cropped photograph shows the fireball formed on the east face of WTC 2 following the aircraft impact that took place 1.1 s earlier. The east face of WTC 1 is visible in the background

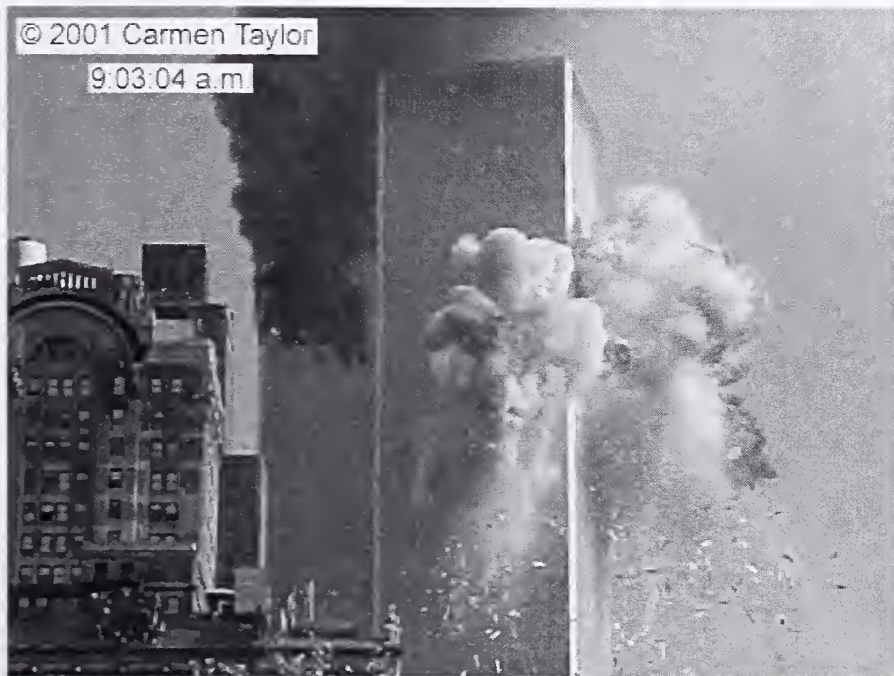
As the fireballs continued to burn, buoyancy forces due to the heated gases began to dominate, and the fireballs were carried upward. Figure 7-3 shows the fireballs on the south and east faces of WTC 2 observed 4.3 s after the aircraft impact. Their appearances are very much changed from those in Figure 7-1 and Figure 7-2. Burning is now observed at heights well above where the aircraft impacted, and both fireballs have become more spherical in shape. Large amounts of dust and larger debris are seen falling downward below the fireballs. The fireball on the east face is considerably larger than that on the south.

Figure 7-3. An image of WTC 2 recorded from the southeast is shown. The photograph was taken 4.3 s after the aircraft impact on the tower. The south face of WTC 1 can be seen burning in the background.

Burning on the south face seems to be concentrated more on the west side, with little flame evident in the dust cloud toward the east.

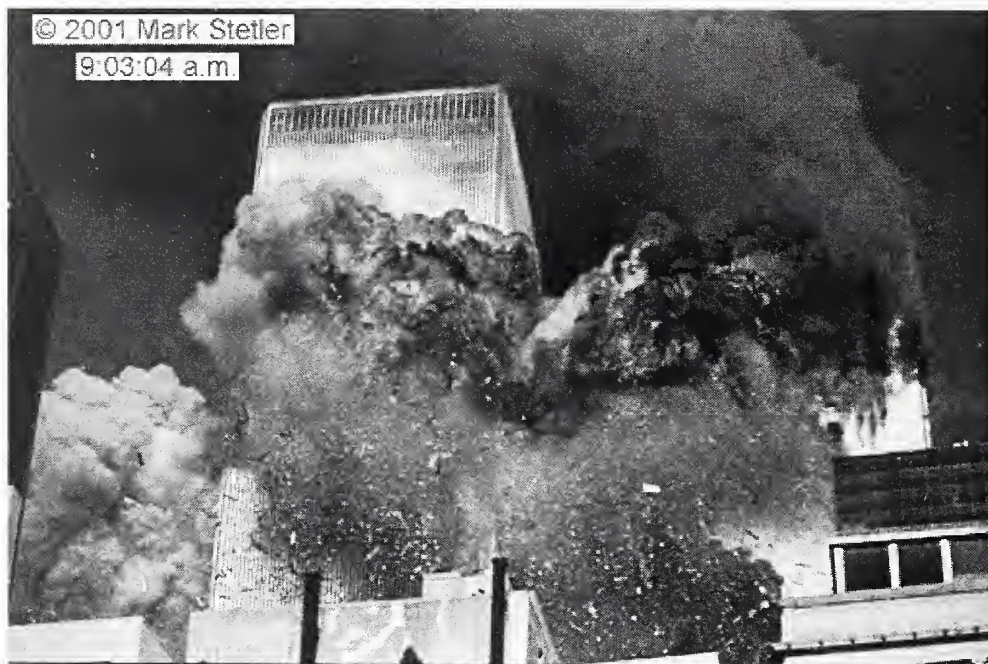
Figure 7-4 shows a photograph of the fireballs taken from just north of due east 4.6 s after the aircraft impact. The features of the fireballs are similar to those already described. The large extent of the fireball on the north face is apparent by noting that the width of each tower is 209 ft. The large amount of dust and larger debris (some flaming) generated by the collision and fireballs can be seen falling below the fireballs. Some isolated regions of fire are evident in the dust cloud on the south face.

Figure 7-4. An image of the fireball on WTC 2 recorded from just north of due east is shown. The photograph was taken 4.6 s after the aircraft impact on the tower.

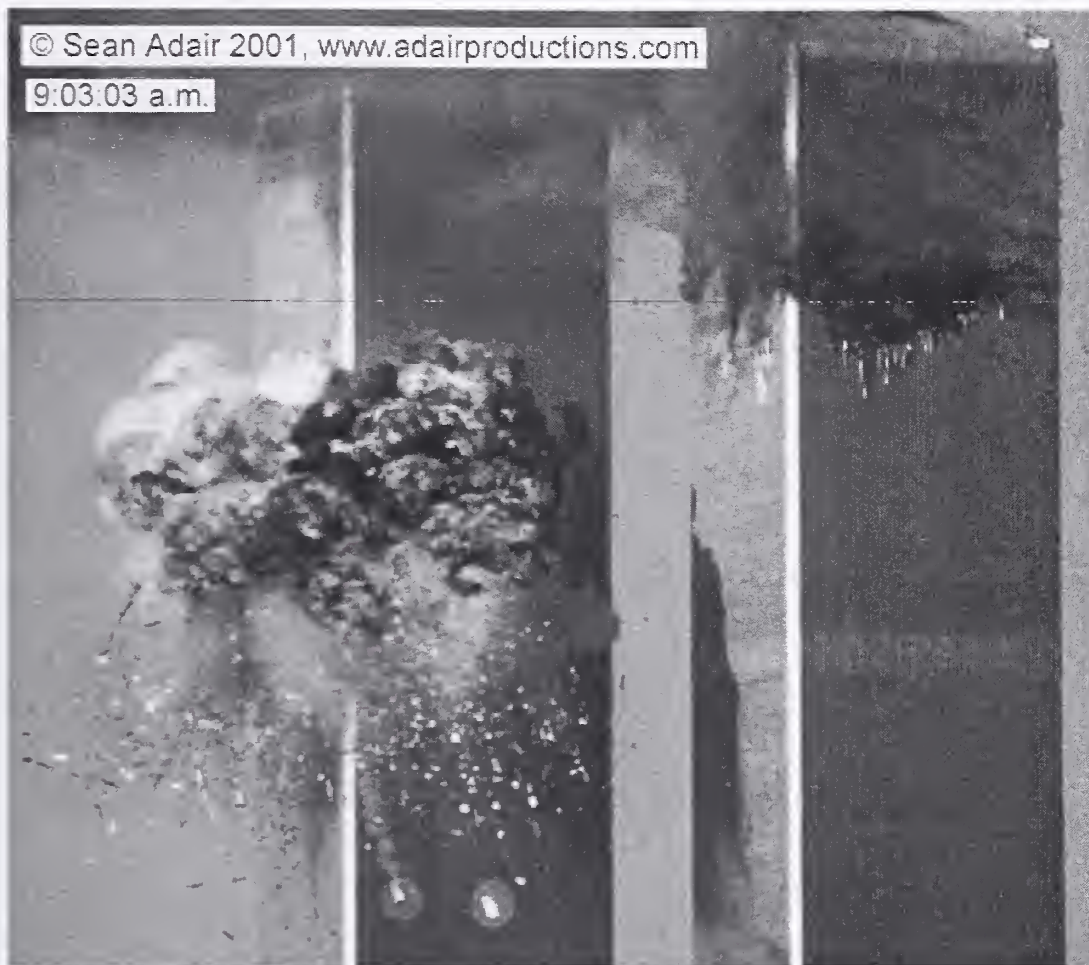
Figure 7-5. An image of the towers recorded from the north northeast is shown. The photograph was taken 4.3 s after the aircraft impact on WTC 2. Highlighted areas show two large pieces of aircraft debris that passed through the building and landed in the vicinity of the Church and Murray Streets intersection.

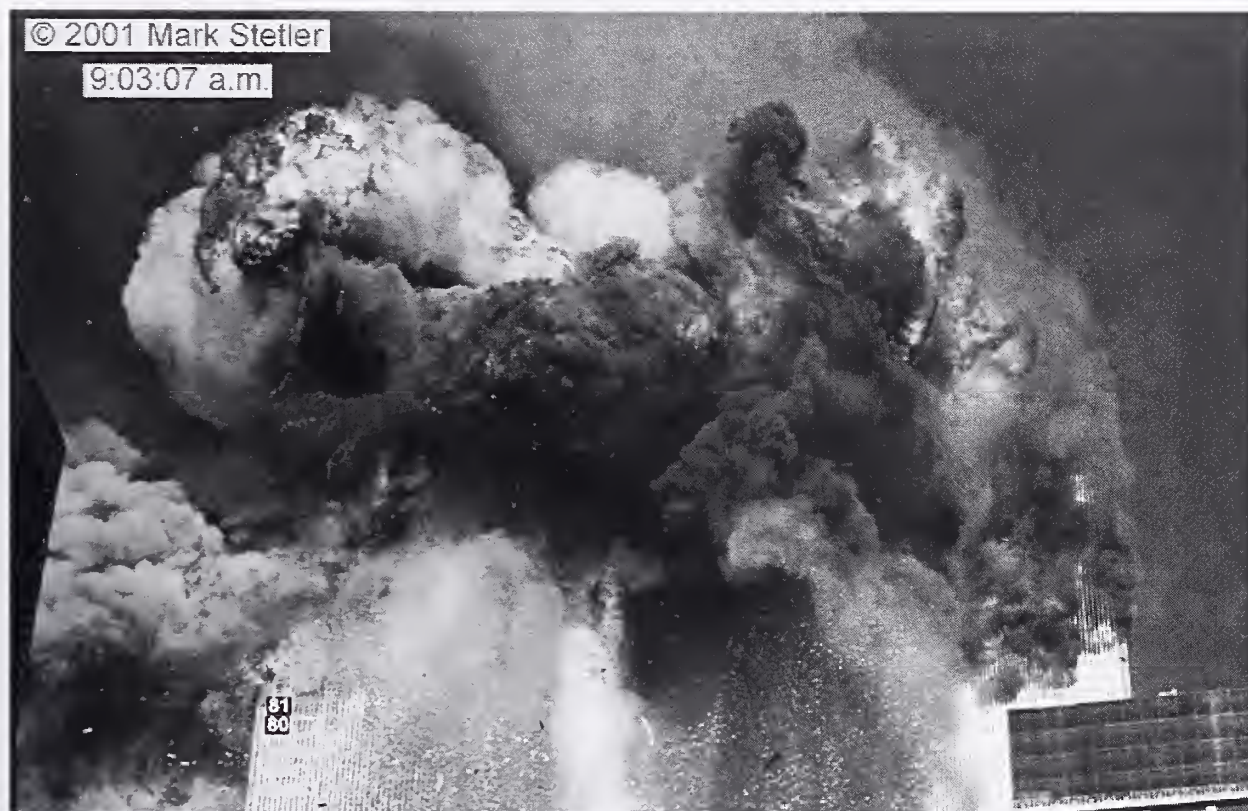
Figure 7-7 is an image recorded 7.9 s following the aircraft impact from the same perspective as Figure 7-4. The large fireball formed by the rapid expulsion of aviation fuel from the tower immediately following the aircraft impact has continued to rise and has begun to separate from the release point. Intense flaming is still seen in the vicinity of the building where the aircraft impact occurred. Even though significant façade damage is evident on the south side of the east face over three floors (80th, 81st, and 82nd), flames are emanating primarily from the 82nd floor windows. It is possible that flaming from higher windows is also occurring, but is hidden. Similar flaming is evident on the south and north faces.

Figure 7-7. An image of WTC 2 recorded from just north of due east is shown. The photograph was taken 7.9 s after the aircraft impact on the tower. The locations of the 80th and 81st floors are identified

Large amounts of debris and dust are falling from the central region of the east face. Some of this debris is higher than the aircraft impact floors. This indicates that a portion of the debris that was expelled from the building was initially carried upward by the fireball. Since the debris is heavier than air, it eventually loses its upward momentum and drops from the bottom of the fireball.

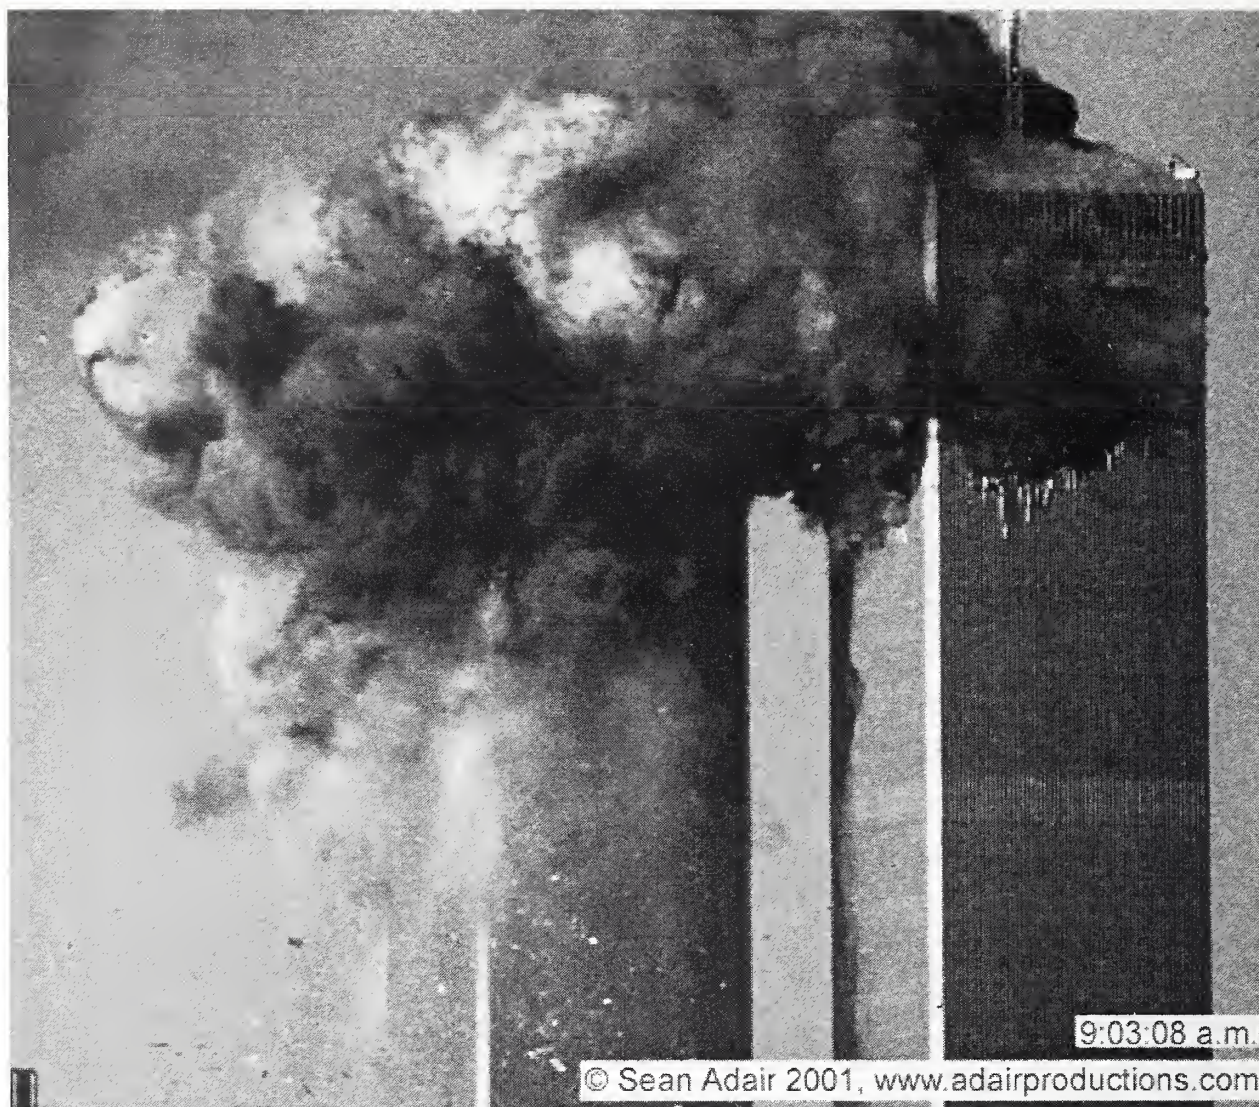
Figure 7-8 shows a northern view of the fireball taken 8.7 s after the aircraft impact. The perspective is the same as in Figure 7-5. The appearance of the fireball is consistent with that described for Figure 7-7, but the amount of visible flame in the fireball appears to be significantly reduced, indicating that it is beginning to burn out. There appears to be a large amount of debris falling on the northeast corner of the tower and considerably less from regions of the north face more toward the center. The falling debris on the northeast corner is evident in Figure 7-7 as well. Similar to the east face photographs shown in Figure 7-6 and Figure 7-7, which were taken at roughly the same time, significant flaming from the tower is evident below the fireball in the vicinity of the aircraft impact location.

Figure 7-8. An image of the towers recorded from the north northeast is shown. The photograph was taken 8.7 s after the aircraft struck WTC 2.

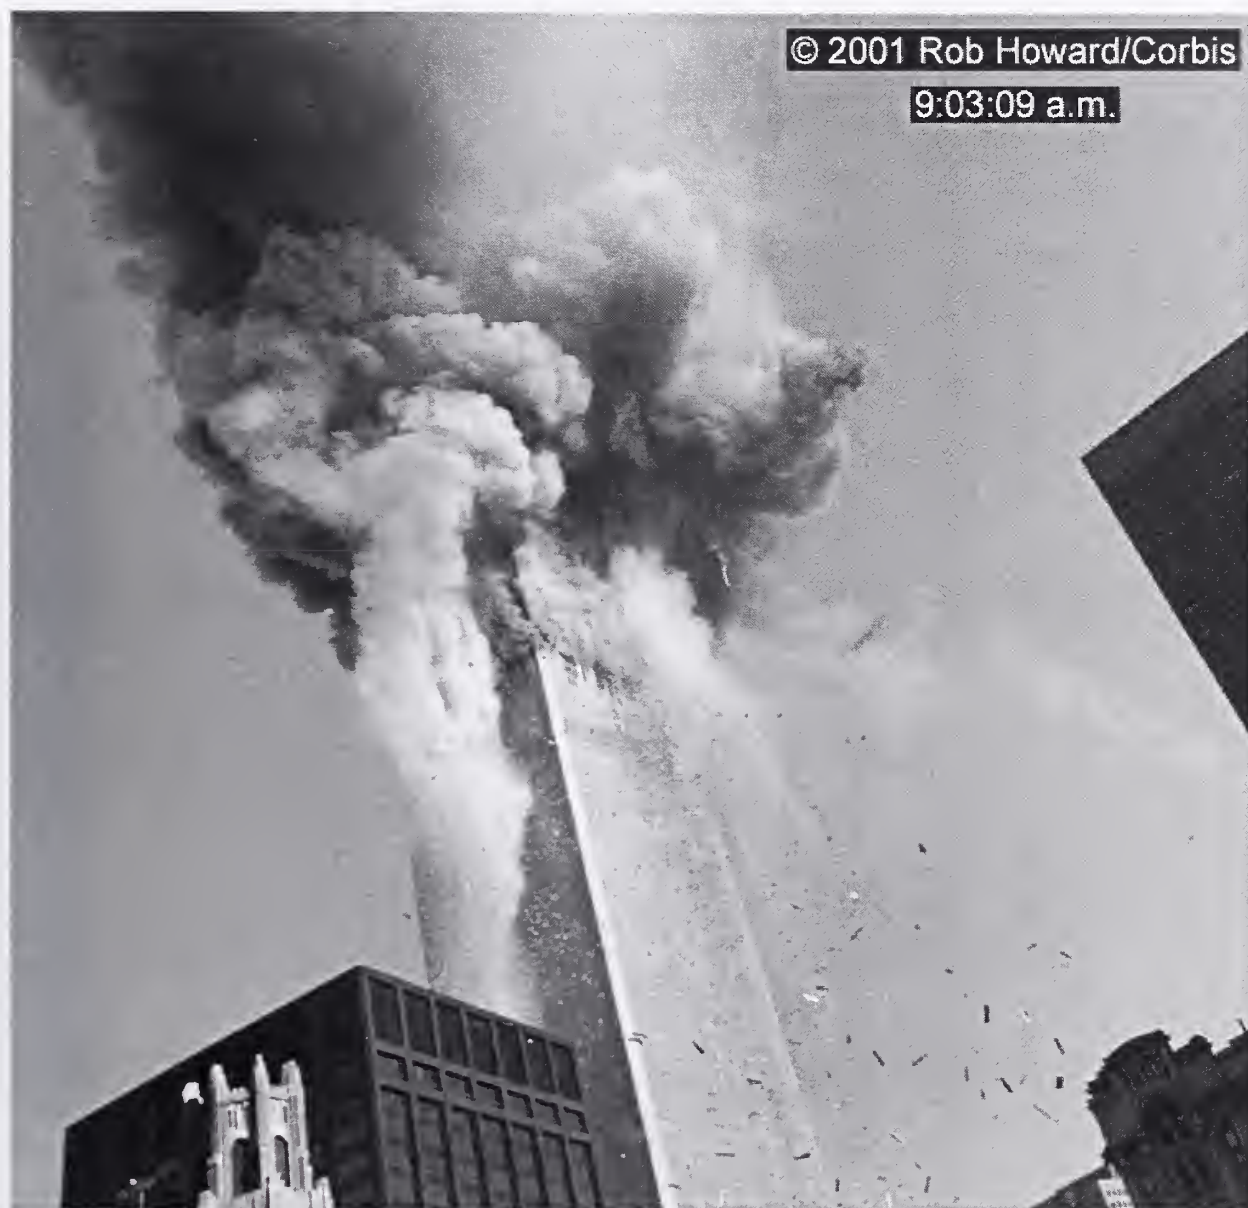
Figure 7-9, taken 10 s after the second aircraft struck WTC 2, shows the debris and dust clouds on the south and east faces of WTC 2. The cloud on the south face is much larger than that on the east face. This is consistent with the conclusion that more debris was expelled from the south face than from either the east face or north face. The observation of a smaller, shorter-lived fireball on the south face suggests that less fuel was consumed by this fireball than those on the east face and north face.

Figure 7-9. This cropped black and white photograph was recorded from the southeast of WTC 2 10 s after the second aircraft impact.

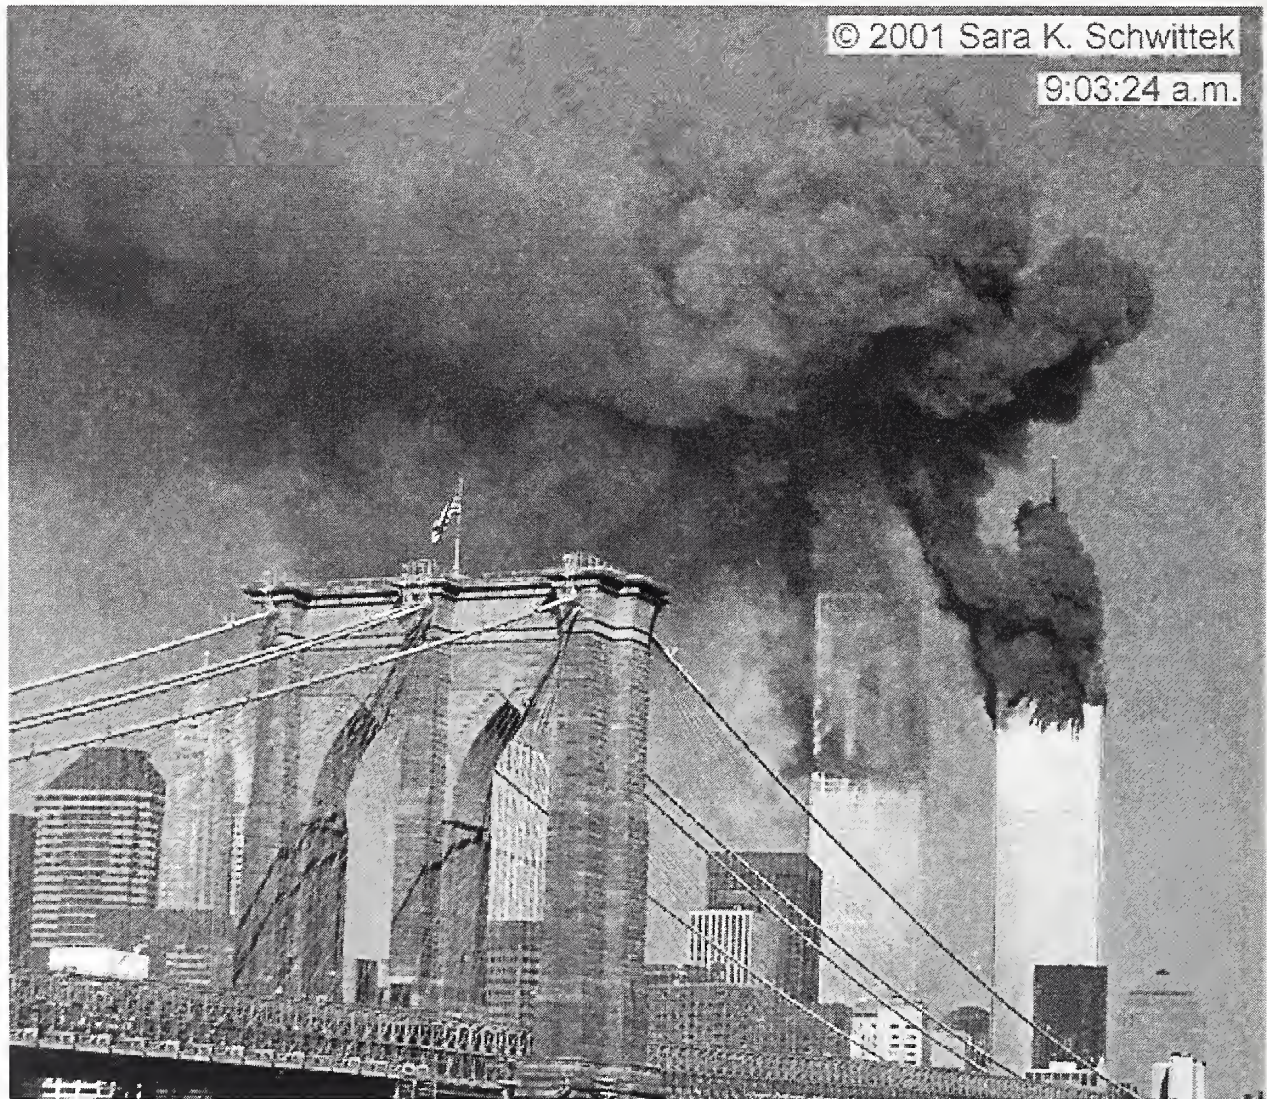
After the flames in the rising fireball extinguished, the heated gases continued to rise, ultimately forming a distinct mushroom cloud. In this report the structure formed by these hot gases from a fireball is referred to as a “thermal” in order to distinguish it from the smoke plumes created by fires burning within the buildings and from the fireballs, which contain flame. Figure 7-10 shows the appearance of the thermal shot from the east from across the East River at 9:03:24 a.m. or 25 s after the aircraft impact. A view of the thermal from the west is shown in Figure 7-11. The exact time of this photograph has not been determined, but it was taken between three and four minutes after the aircraft impact. By simply using the known heights of the towers (roughly 1,365 feet), it is possible to estimate that the center of the head of the thermal had risen more than 1,400 feet in this period of time.

Figure 7-10. This cropped photograph recorded at 9:03:24 a.m., i.e., 25 s after the aircraft impact on WTC 2, shows the nascent thermal created by the fireballs on WTC 2. The intensity levels of the image have been adjusted.

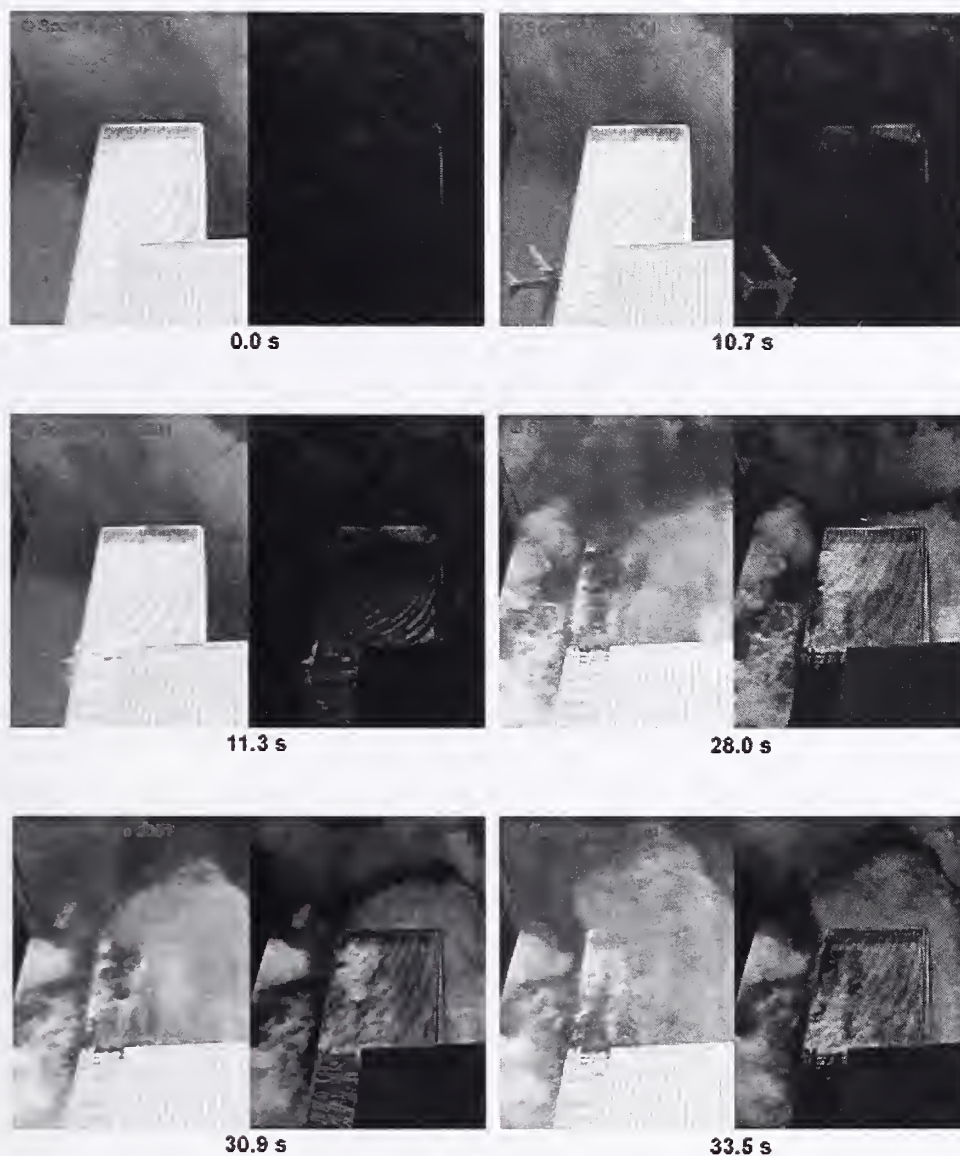
When this approach was applied to the video, a region of windows was observed on the building that seemed to appear and disappear. Figure 7–14 shows several frames of a composite video formed by overlaying half frames of the original video and the difference video. In the initial frame (time = 0.0 s) the aircraft has not yet appeared, and the difference frame is black. In the next frame (time = 10.7 s) the aircraft is approaching the building. The aircraft is evident in the difference frame since it represents a change in the frame. WTC 2 is still dark except near the top where changes due to smoke movement are apparent. In the third frame (time = 11.3 s) the aircraft has struck the building and dramatic changes in the appearance of the building façade in the difference frame are evident. Close inspection shows what appear to be curved lines running across the face of WTC 2. These curves result from an interaction between the straight lines formed by the windows and columns on the tower and the straight lines of picture elements (pixels) that make up the detector in the digital video camera. This well known behavior is called the moiré effect. As discussed in the following section, the moiré effect provides a sensitive approach for determining the displacement of the building as a function of time and allows a detailed analysis of the various oscillation frequencies of the tower following the aircraft impact.

Following the aircraft impact, areas of the tower face above the strike floors became hidden by smoke, and these areas do not provide useful information. However, the area of the tower below the strike floors to the left of the building in the foreground continues to show a distinct difference pattern since it is not obscured by smoke. This pattern is apparent in the fifth frame (time = 30.9 s). On the other hand, frames 4 and 6 (times = 28.0 s and 33.5 s, respectively) have been chosen for display because they are near null points, and the area appears dark in the difference frames since the location of the building is essentially unchanged from its position prior to the aircraft impact. When the video is played, the patterns in this area of the tower face alternately appear and disappear in the difference video.

Figure 7-14. Frames from a composite video are shown. The half frames on the left are taken from a video showing the aircraft impact on WTC 2, while the half frames on the right are generated by subtracting a frame recorded prior to the aircraft impact from all subsequent frames in the original video. Times refer to the period since the start of the difference video.

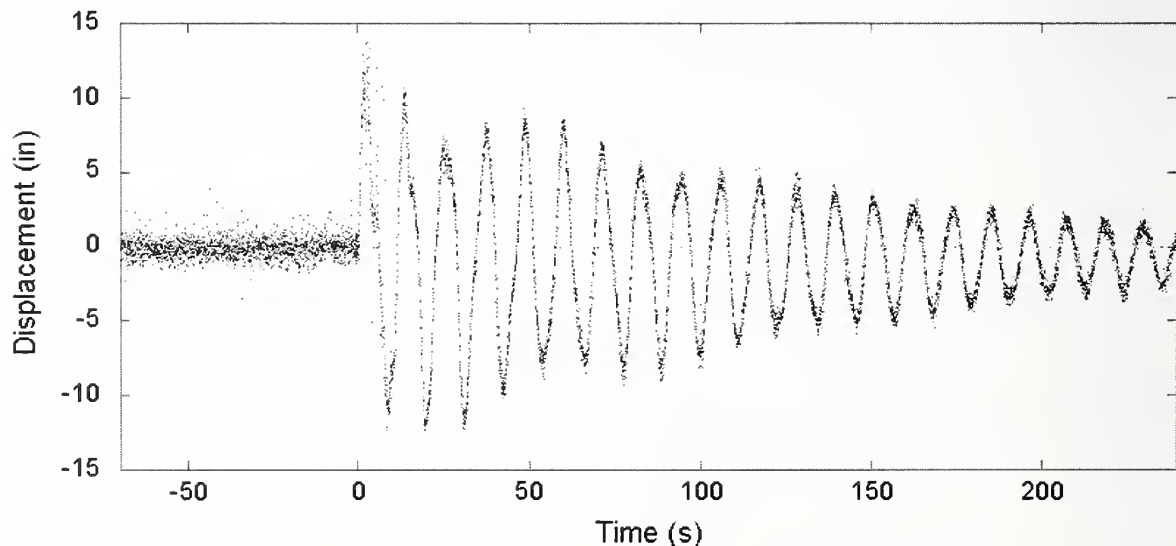
Figure 7-18. The displacement of the first (left-most) window line on the 70th floor of WTC 2 determined using moiré analysis is shown as a function of time.

Detailed frequency analysis of the displacement data shown in Figure 7-18 revealed the fundamental north-south mode with a period of 11.4 s, a torsional mode with a period of 5.3 s, and two higher frequency modes with periods of 3.9 s and 2.2 s. All periods are accurate to better than ± 0.1 s. The period of the fundamental mode is comparable to the computational value for WTC 2 and within normal expected variations as evidenced by measurements on WTC 1 (NIST NCSTAR 1-2). The torsional mode dominates the window spacing variation, as twisting of the building makes the camera's viewing angle of the east face alternatively more and less perpendicular. The highest frequency mode causes some jerkiness in the motion over the first few oscillations.

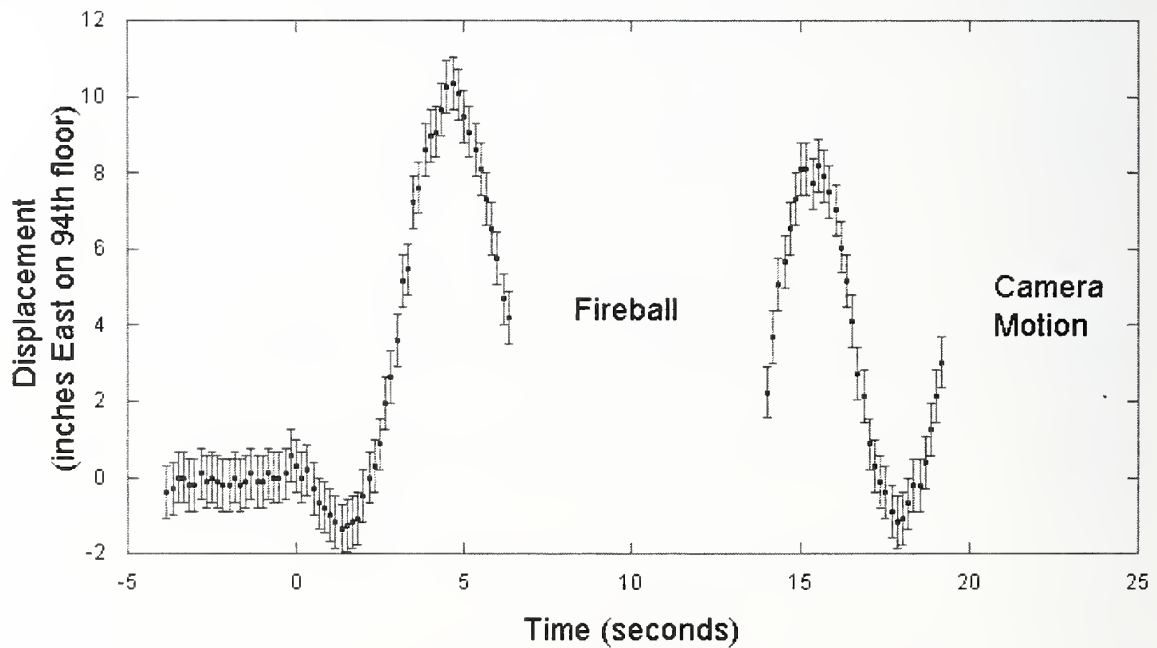
Although the motion of WTC 2 in this video covers less than a pixel width horizontally, the moiré pattern for the nearly vertical lines of windows greatly amplifies this motion. Figure 7-20 shows the calculated east-west displacement of the 94th floor of WTC 2, with a total apparent sway of 12 in. \pm 2 in. A frequency analysis of this brief set of data yielded a period of 5.3 s. This is consistent with the torsional mode found in the analysis of north-south motion and can be explained as follows. The aircraft struck WTC 2 on the south face off-center toward the east while moving toward the northeast relative to the tower. As a result, the tower was twisted in the counter-clockwise direction as seen from above, i.e., the aircraft impact imparted a brief angular momentum as seen from above. To an observer from the north, points on the north face appeared to suddenly move toward the west. The tower resisted this motion and tried to return to its original position. In doing so, it rotated clockwise, causing the apparent motion to the east evident in Figure 7-20. The torsional motion would have continued until it died down. It is uncertain why the estimated building motion is asymmetric relative to the original undisturbed position.

Figure 7-20. East-west motion of WTC 2 just before and after the aircraft impact. Error bars indicate measurement uncertainty.

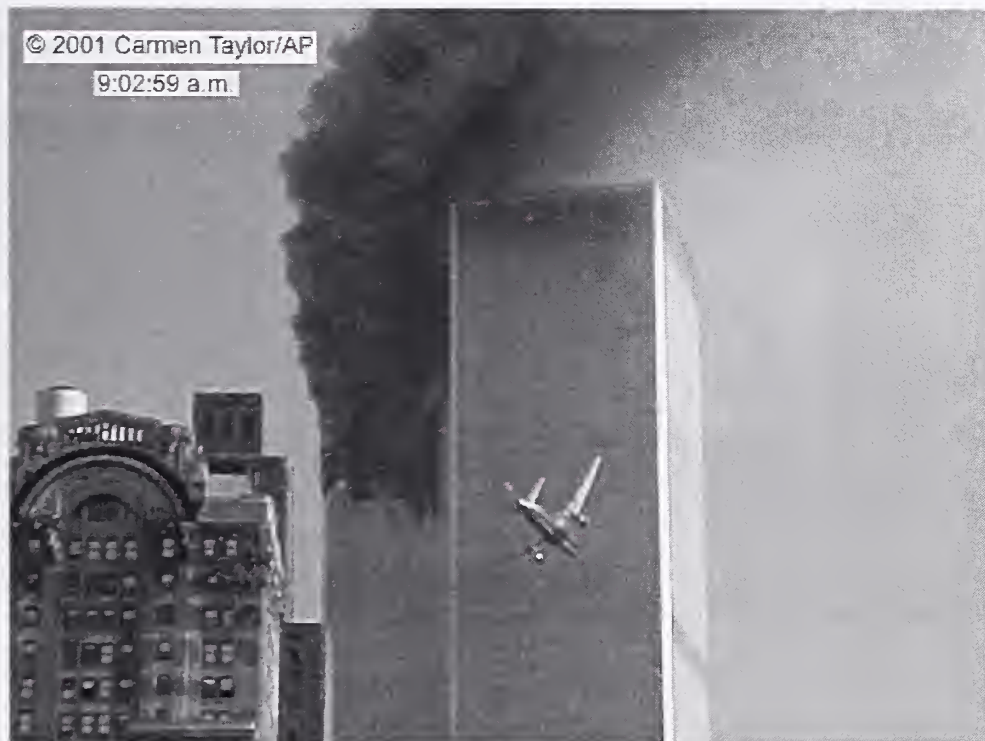
Figure 7-21 shows a photograph that was taken just prior to United Airlines Flight 175 striking WTC 2. The right wing of the aircraft is raised, as if the aircraft was turning to the left. Videos show that when the aircraft struck it appeared to disappear into the tower leaving a hole shaped like the aircraft. Very shortly after the aircraft impact, a large cloud of debris and burning aviation fuel exited the tower from the impact location, obscuring the region. Table 7-1 in Section 7.2 details some of the observations during the period immediately following the aircraft impact. As the fireball rose and the dust cloud cleared, the hole in the building became visible once again.

Figure 7-21. This photograph shows United Airlines Flight 175 just prior to its collision with the south face of WTC 2 at 9:02:59 a.m.

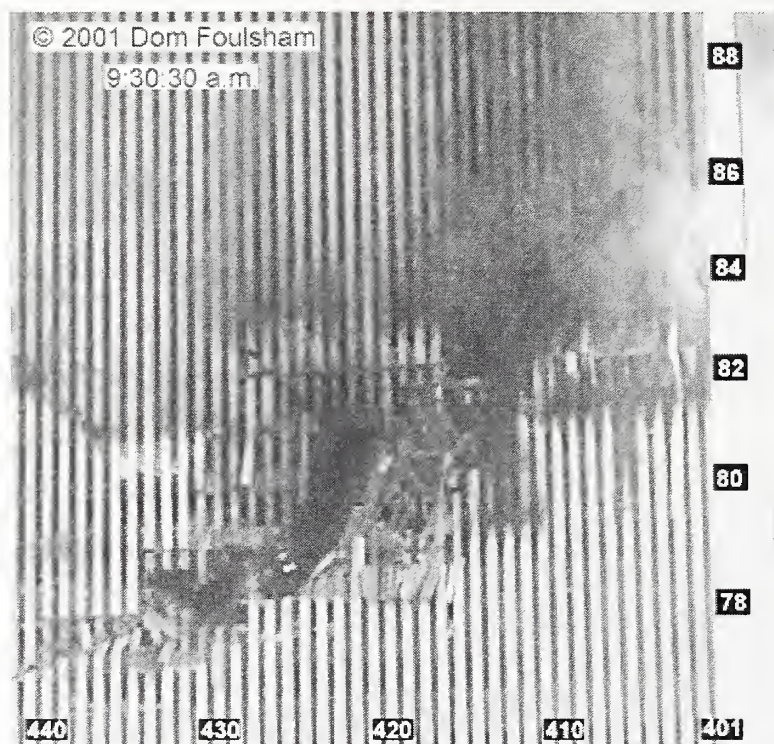
Figure 7-22. This cropped photograph shows the damage to the south face of WTC 2 caused by the aircraft impact. The image was enhanced by adjusting the intensity levels. Column and floor number have been added.

Inspection of Figure 7-22, Figure 7-23, and Figure 7-24 shows that portions of the aluminum cladding that formed the curtain wall for the building were partially or completely removed at locations close to where the aircraft impact occurred. This includes areas on the 80th floor extending from column 80-426 to column 80-431, on the 81st floor extending from column 81-425 to column 81-430, and on the 82nd floor extending from column 82-420 to column 82-426. In Figure 7-24 it can be seen that the aluminum cladding covering the southeast corner on the 82nd floor was pushed outward during the event. It is likely that this occurred as a result of the overpressure within the building generated by burning of aviation fuel released from the tanks of the aircraft. This damage provided a convenient marker for identifying the 82nd floor.

In general, the glass in windows near the aircraft impact location was broken out, while those windows further away tended to remain intact, although some windows were blown open by the overpressure generated by the initial fireball formation within the building. Figure 7-27 is a color-coded representation showing the condition of the windows on the south face in the area immediately following the aircraft impact. Note that a portion of the face was hidden by smoke at this time.
